The Columbia Historic Zoning Commission will meet on Wednesday, November 19, 2025 at 4:00 PM in Council Chambers on the basement level of City Hall, 700 N. Garden Street, to consider the following:

1. Request from Henderick, Inc. for exterior alterations approval at [1122 S. High Street](#), being Tax Map 100E Group E Parcel 17, *Athenaeum Historic District*.
2. Request from Drifter Bay Brewing Co. for exterior alterations approval at [305 W. 11th Street, being located at Tax Map 100E Group E Parcels 18 and 18.01](#), *Athenaeum Historic District*.
3. Request from Marlin Allen Lentz for exterior alterations approval at [222 W. 7th Street, located at Tax Map 99A Group J Parcel 42](#), *Downtown Commercial Historic District*.

**City of Columbia**  
HISTORICAL ZONING COMMISSION  
September 17, 2025

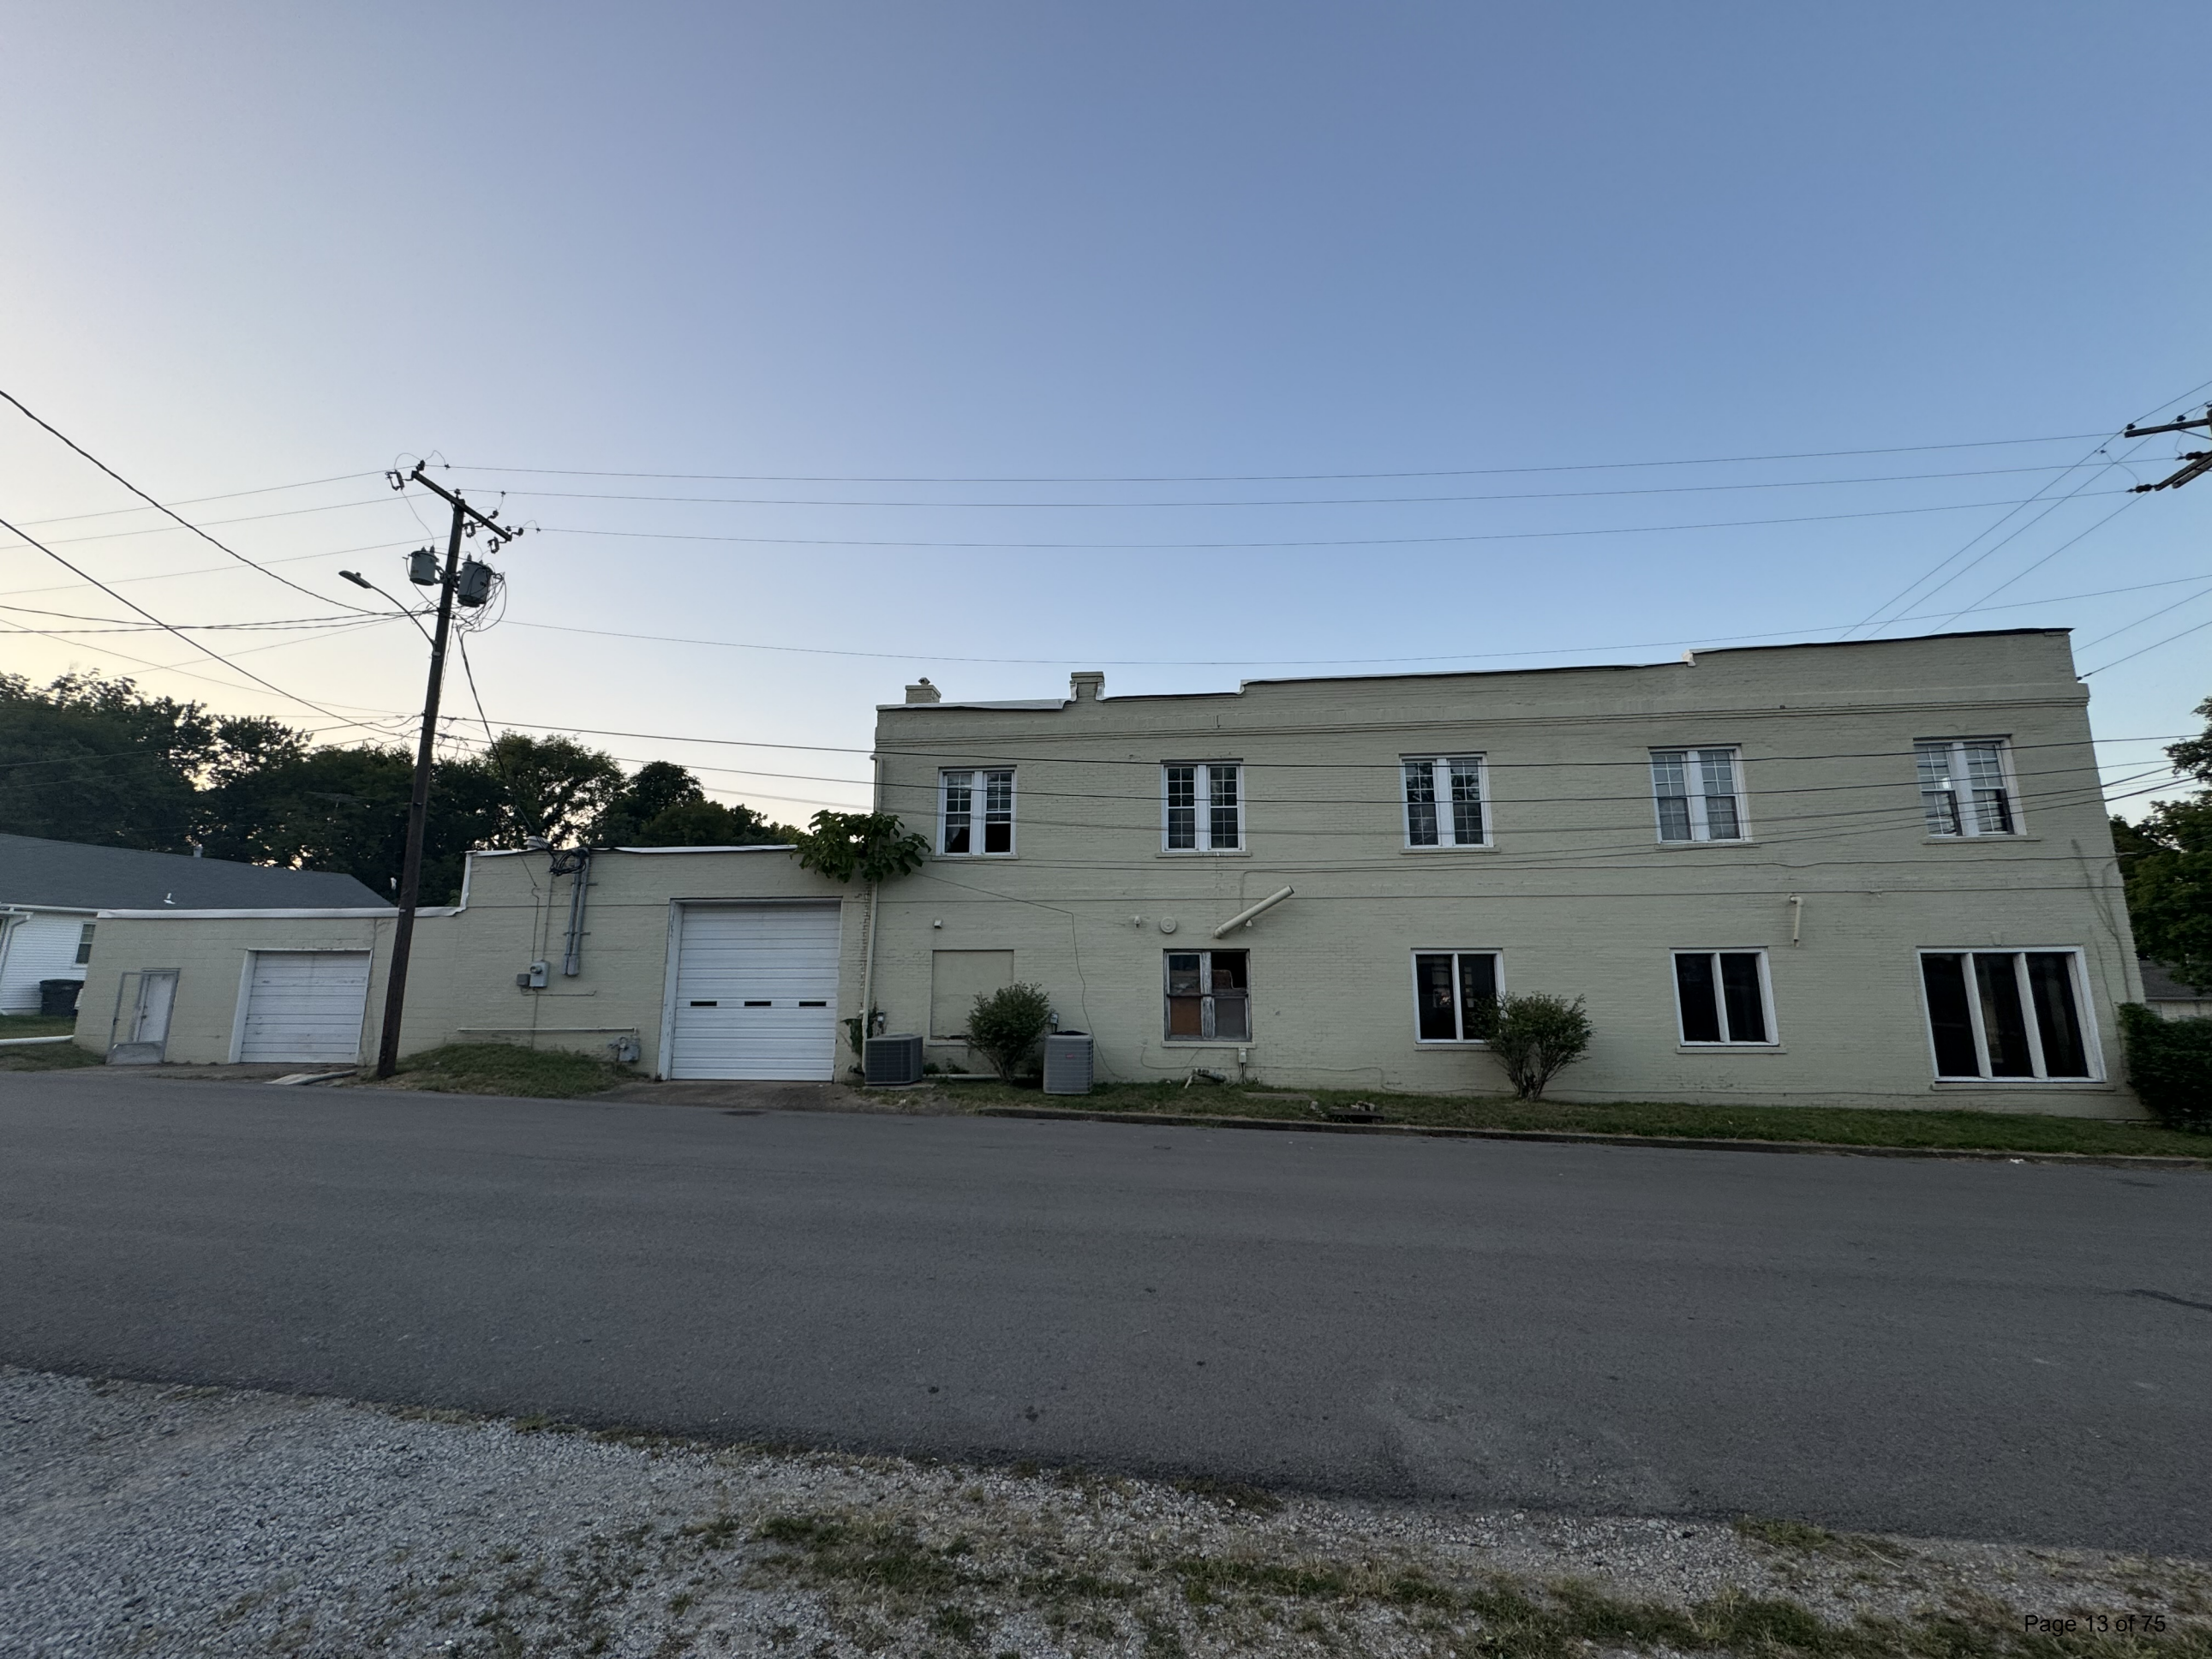
**SERIES SMI-245 ALUMINUM STOREFRONT SYSTEM.**

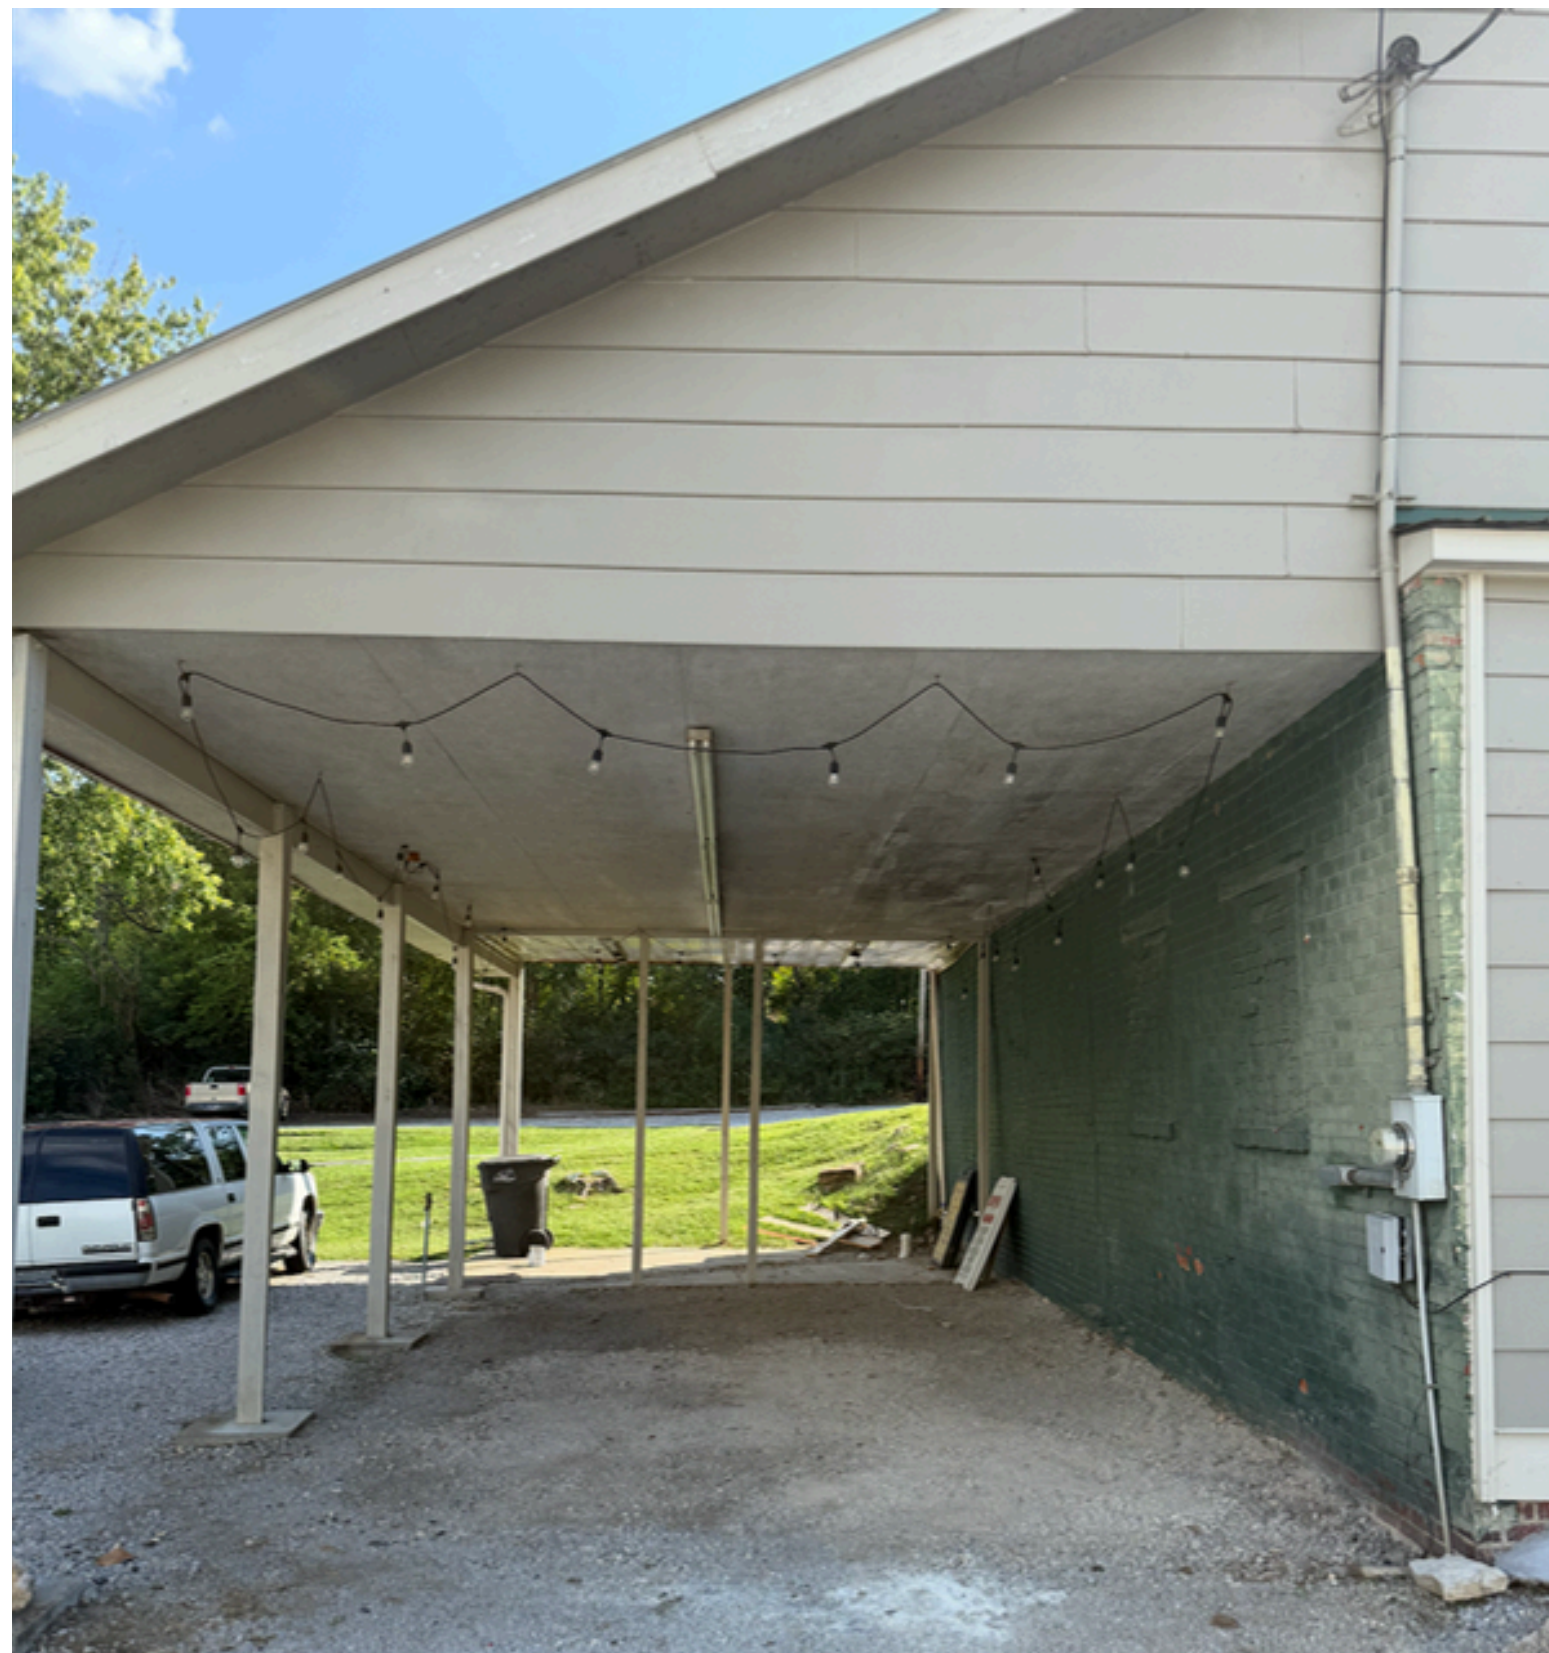
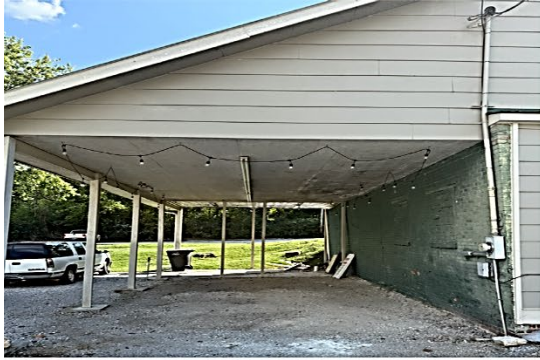
Existing Primary Elevation - Carport Area

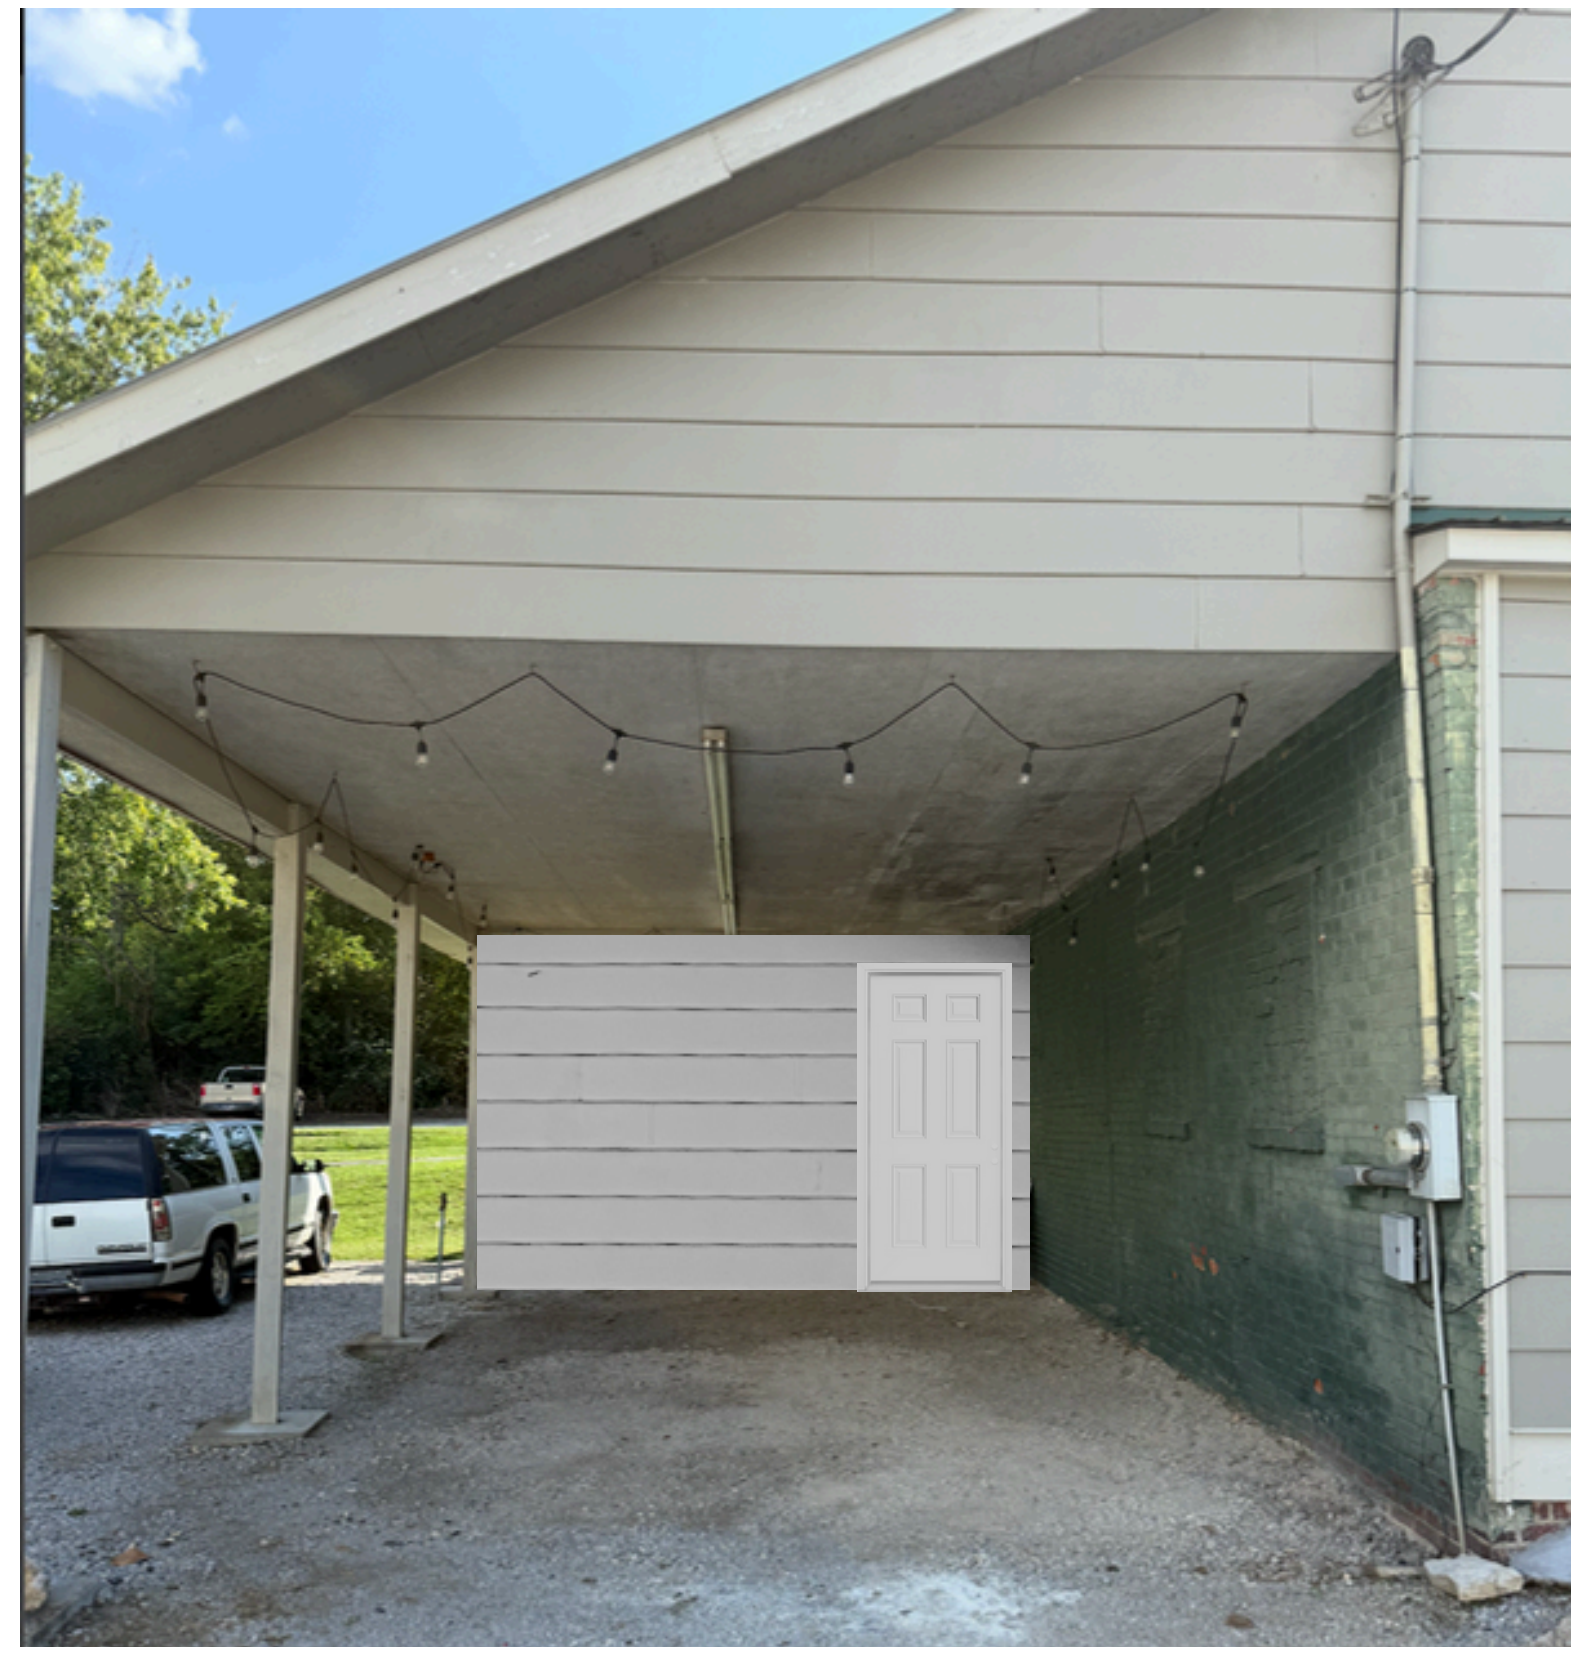
Create walls to match existing siding around the back area.  
This will shield the new boiler on all 3 exposed sides.  
There will be 2 fixed louvers on the left wall and a door on the front wall.

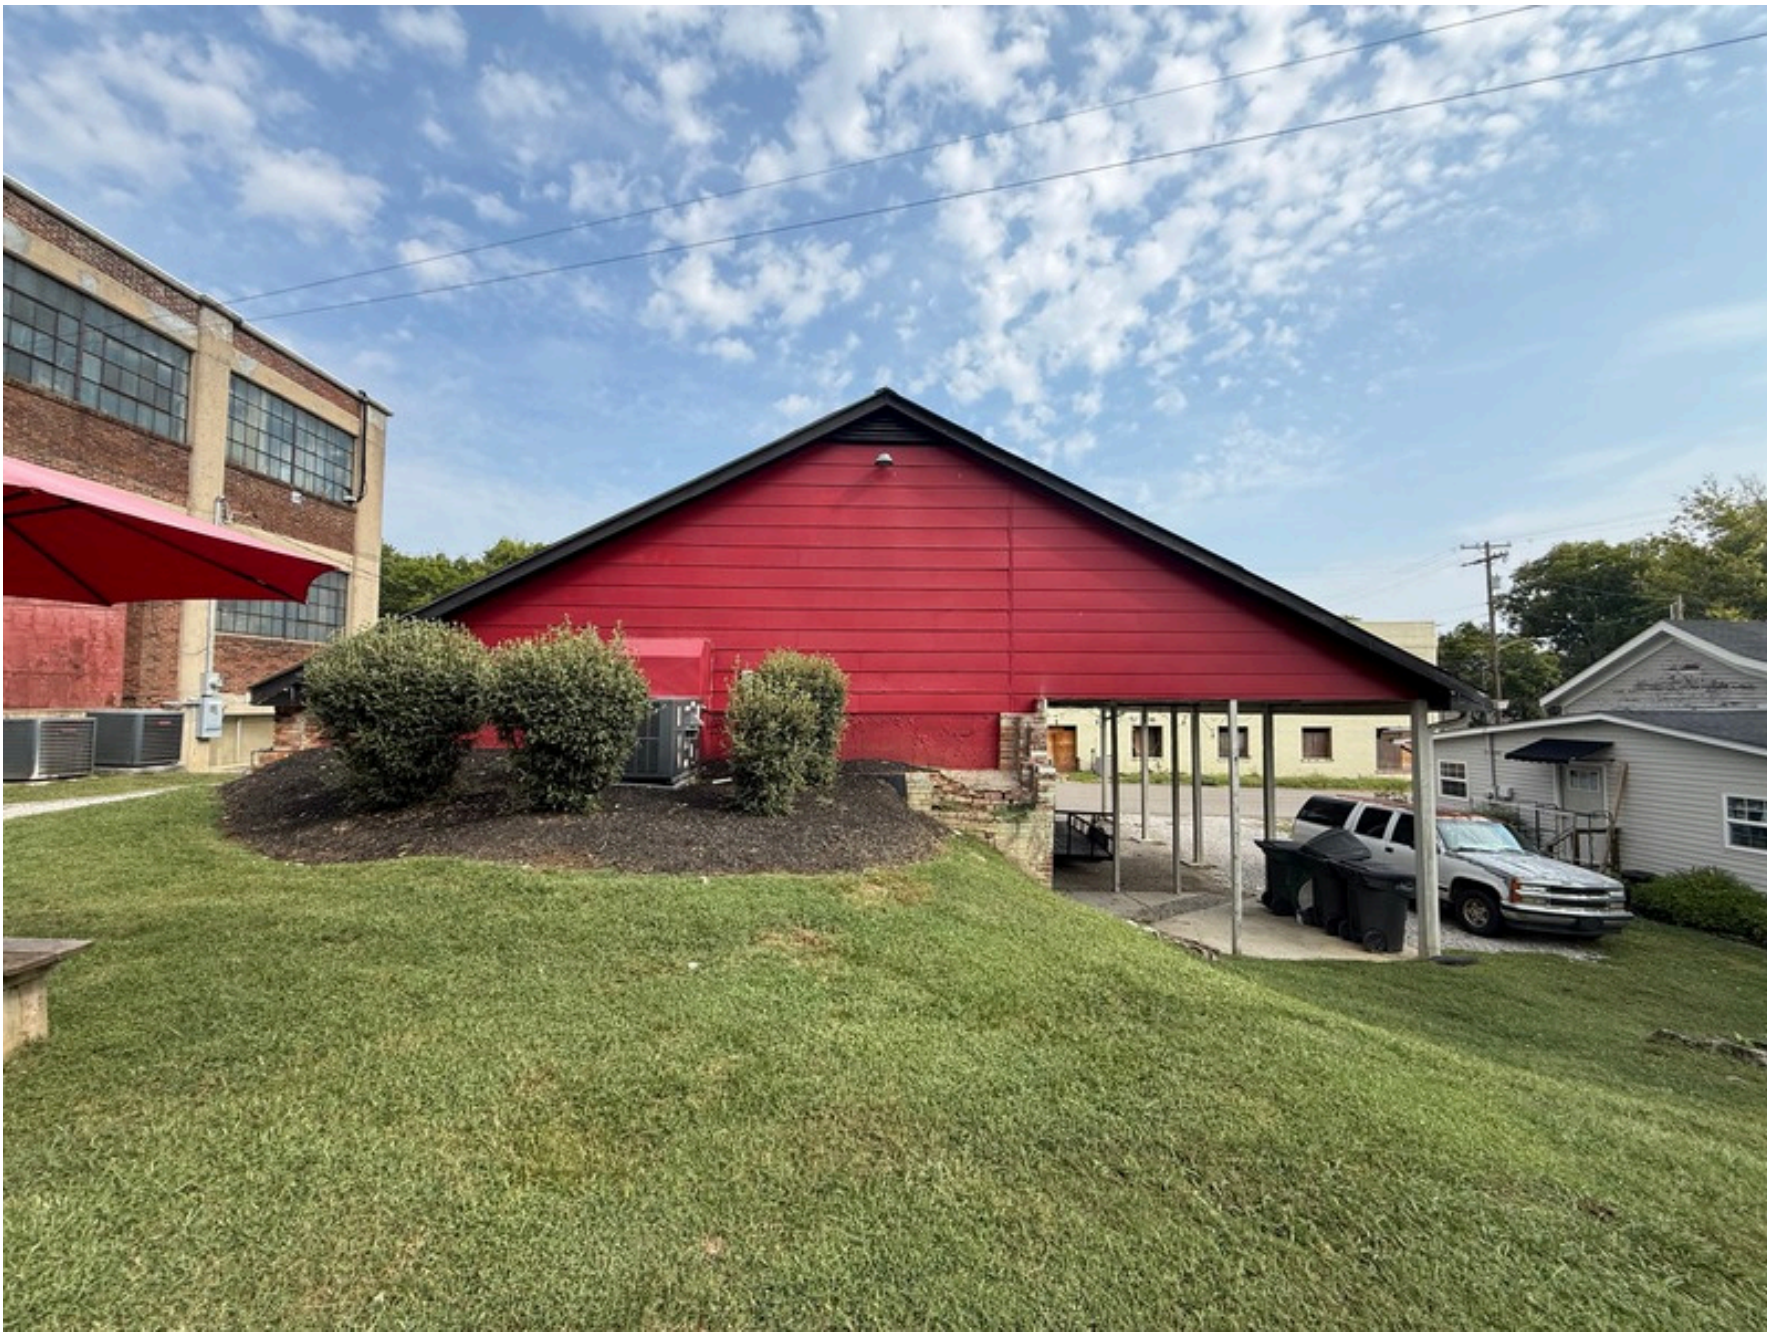
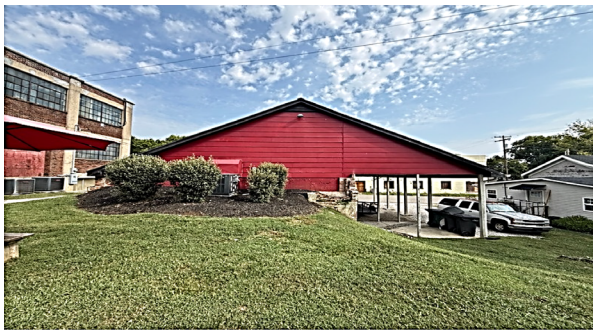
Existing Secondary Elevation

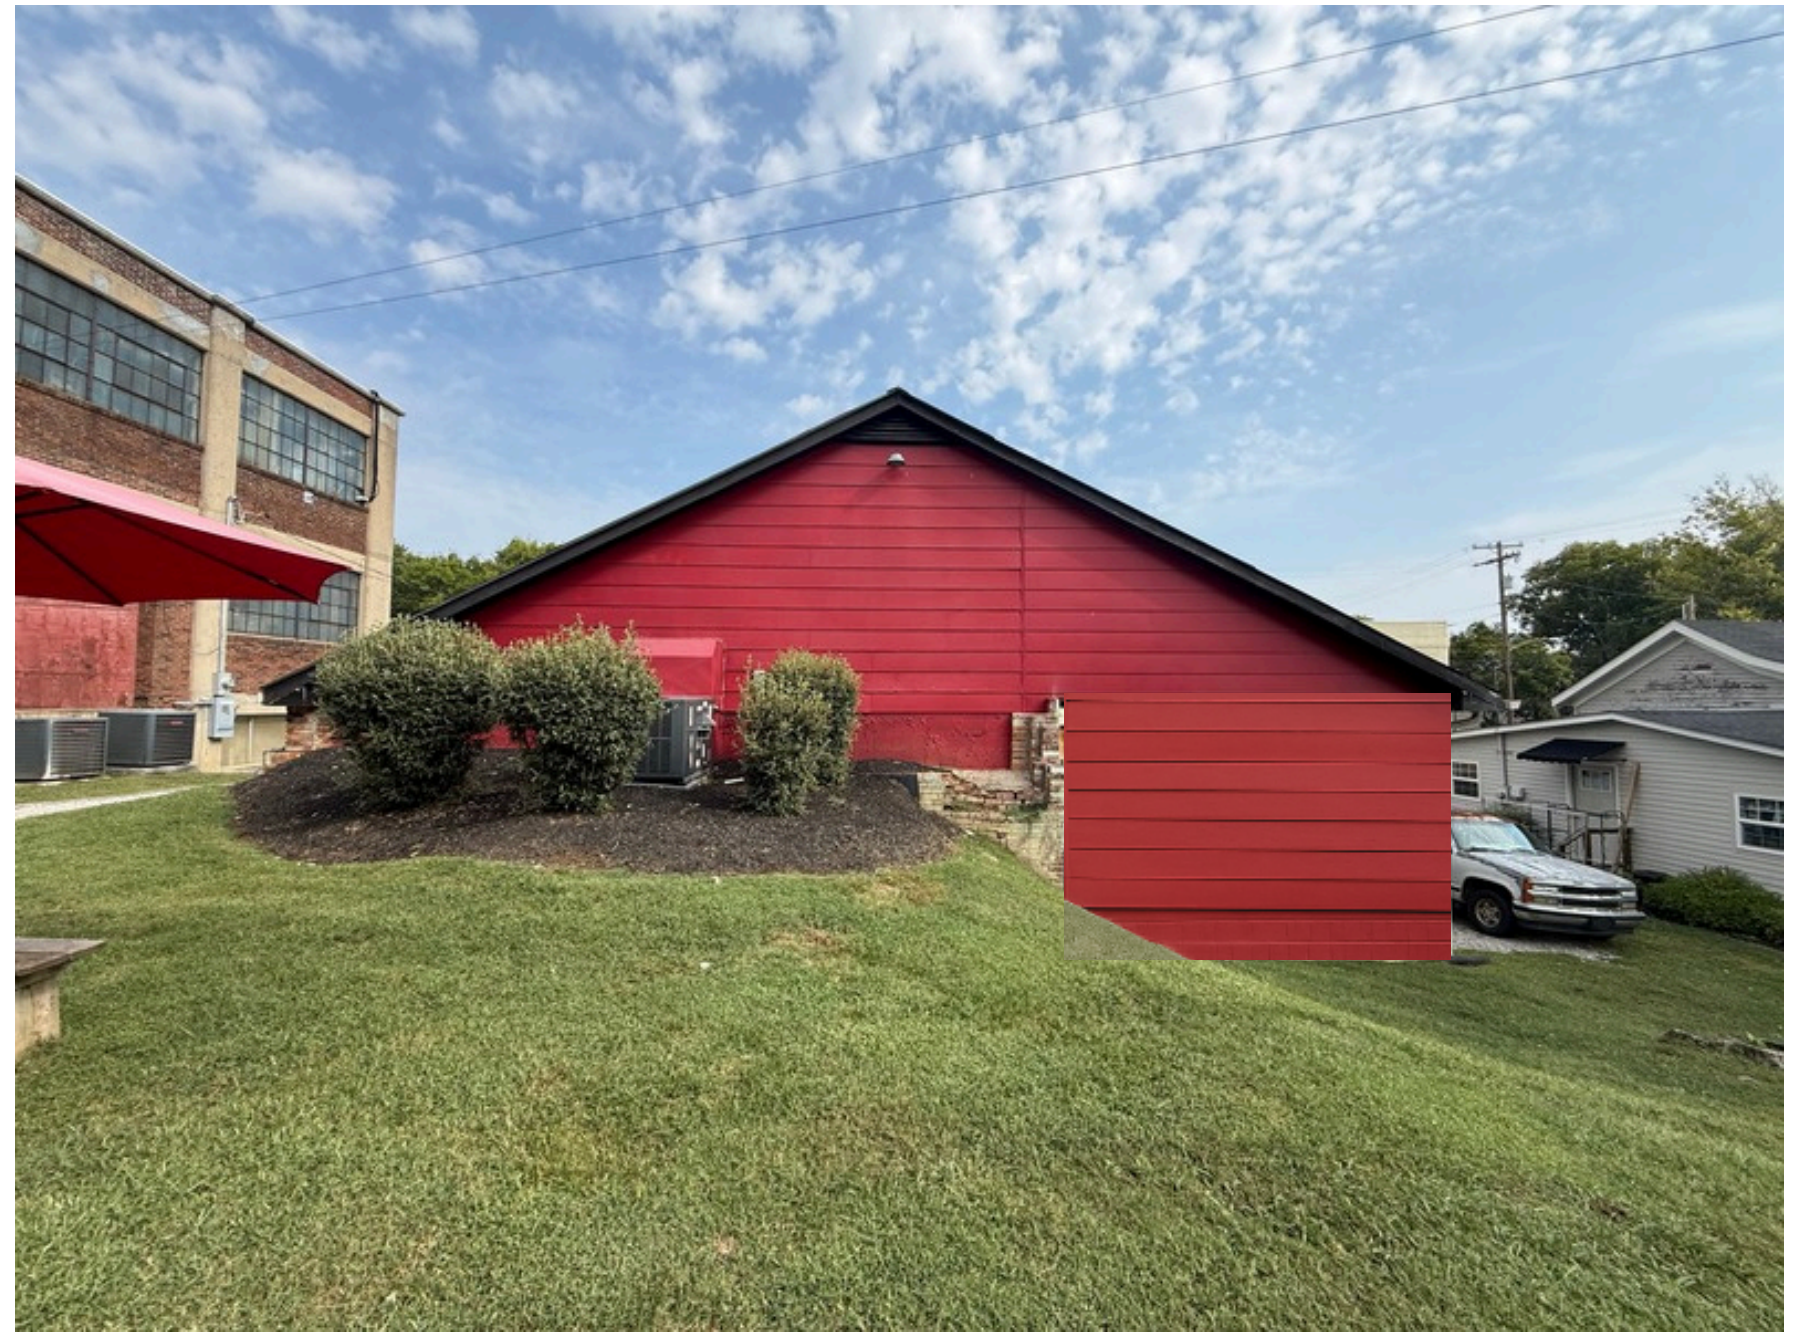
Shown with wall extended to screen boiler equipment in the back of the carport, match existing siding

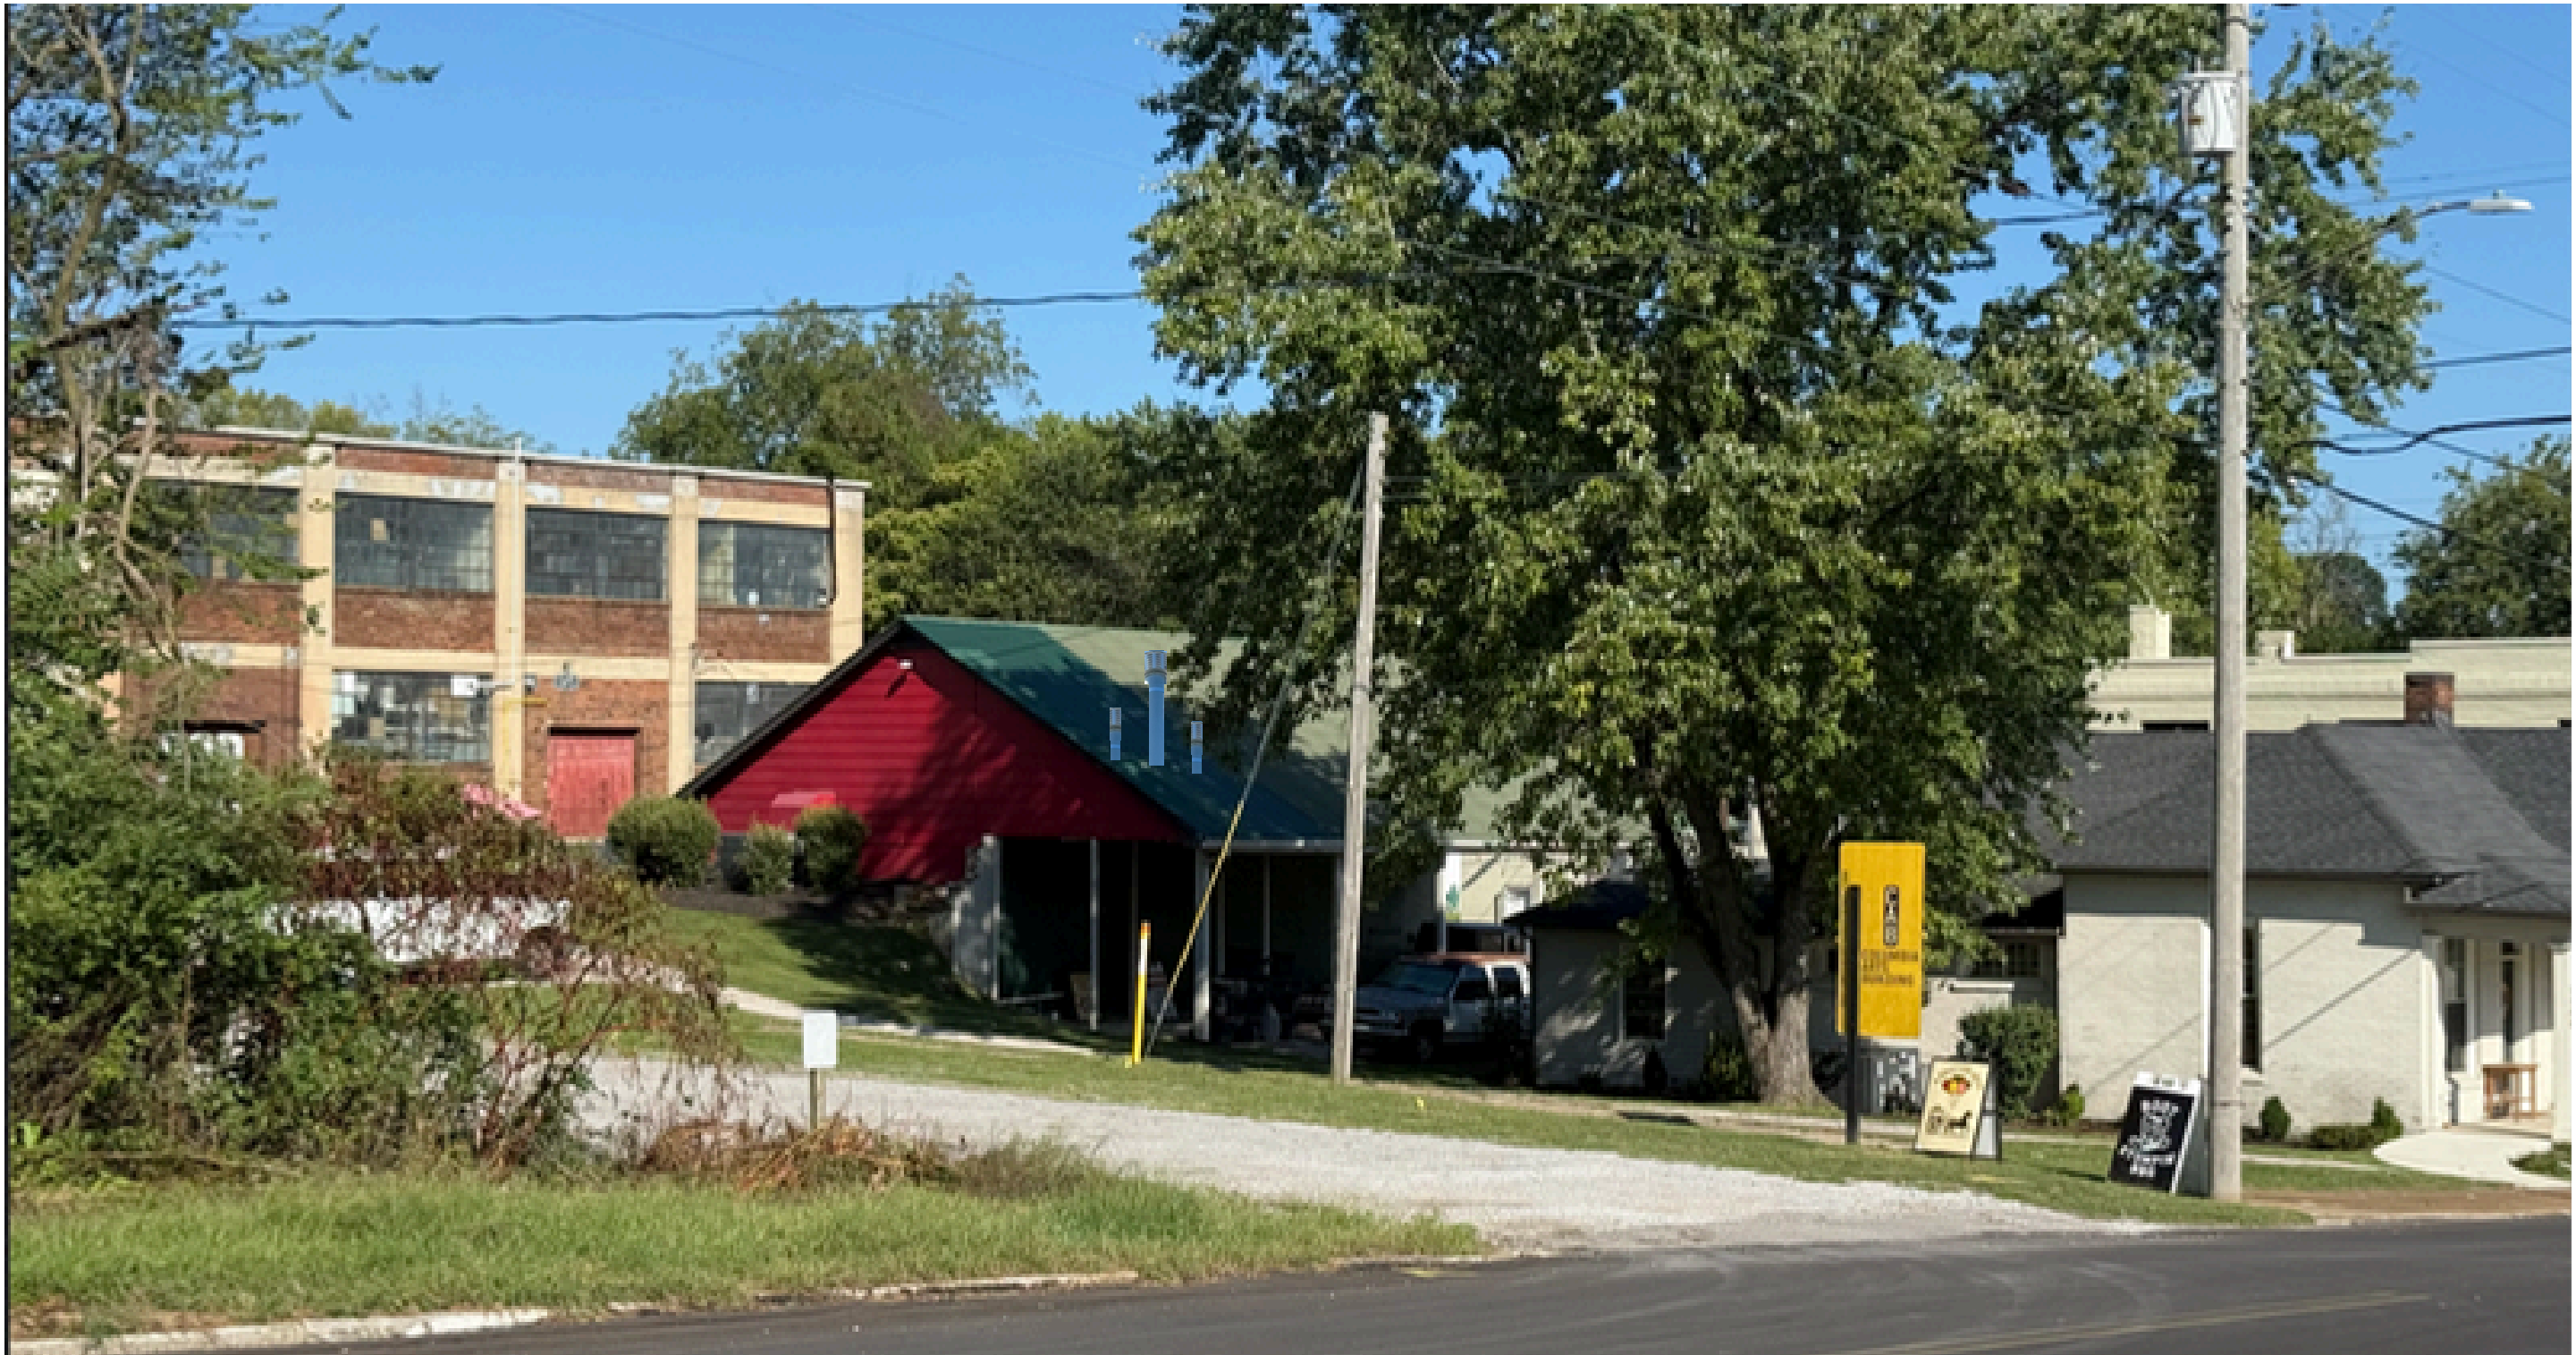
View from S. High Street - shows example of 7' tall 12" boiler vent. Also shows 30" tall 2" return vent, and 30" tall 3" blowdown vent which may not be required depending on final equipment selection.

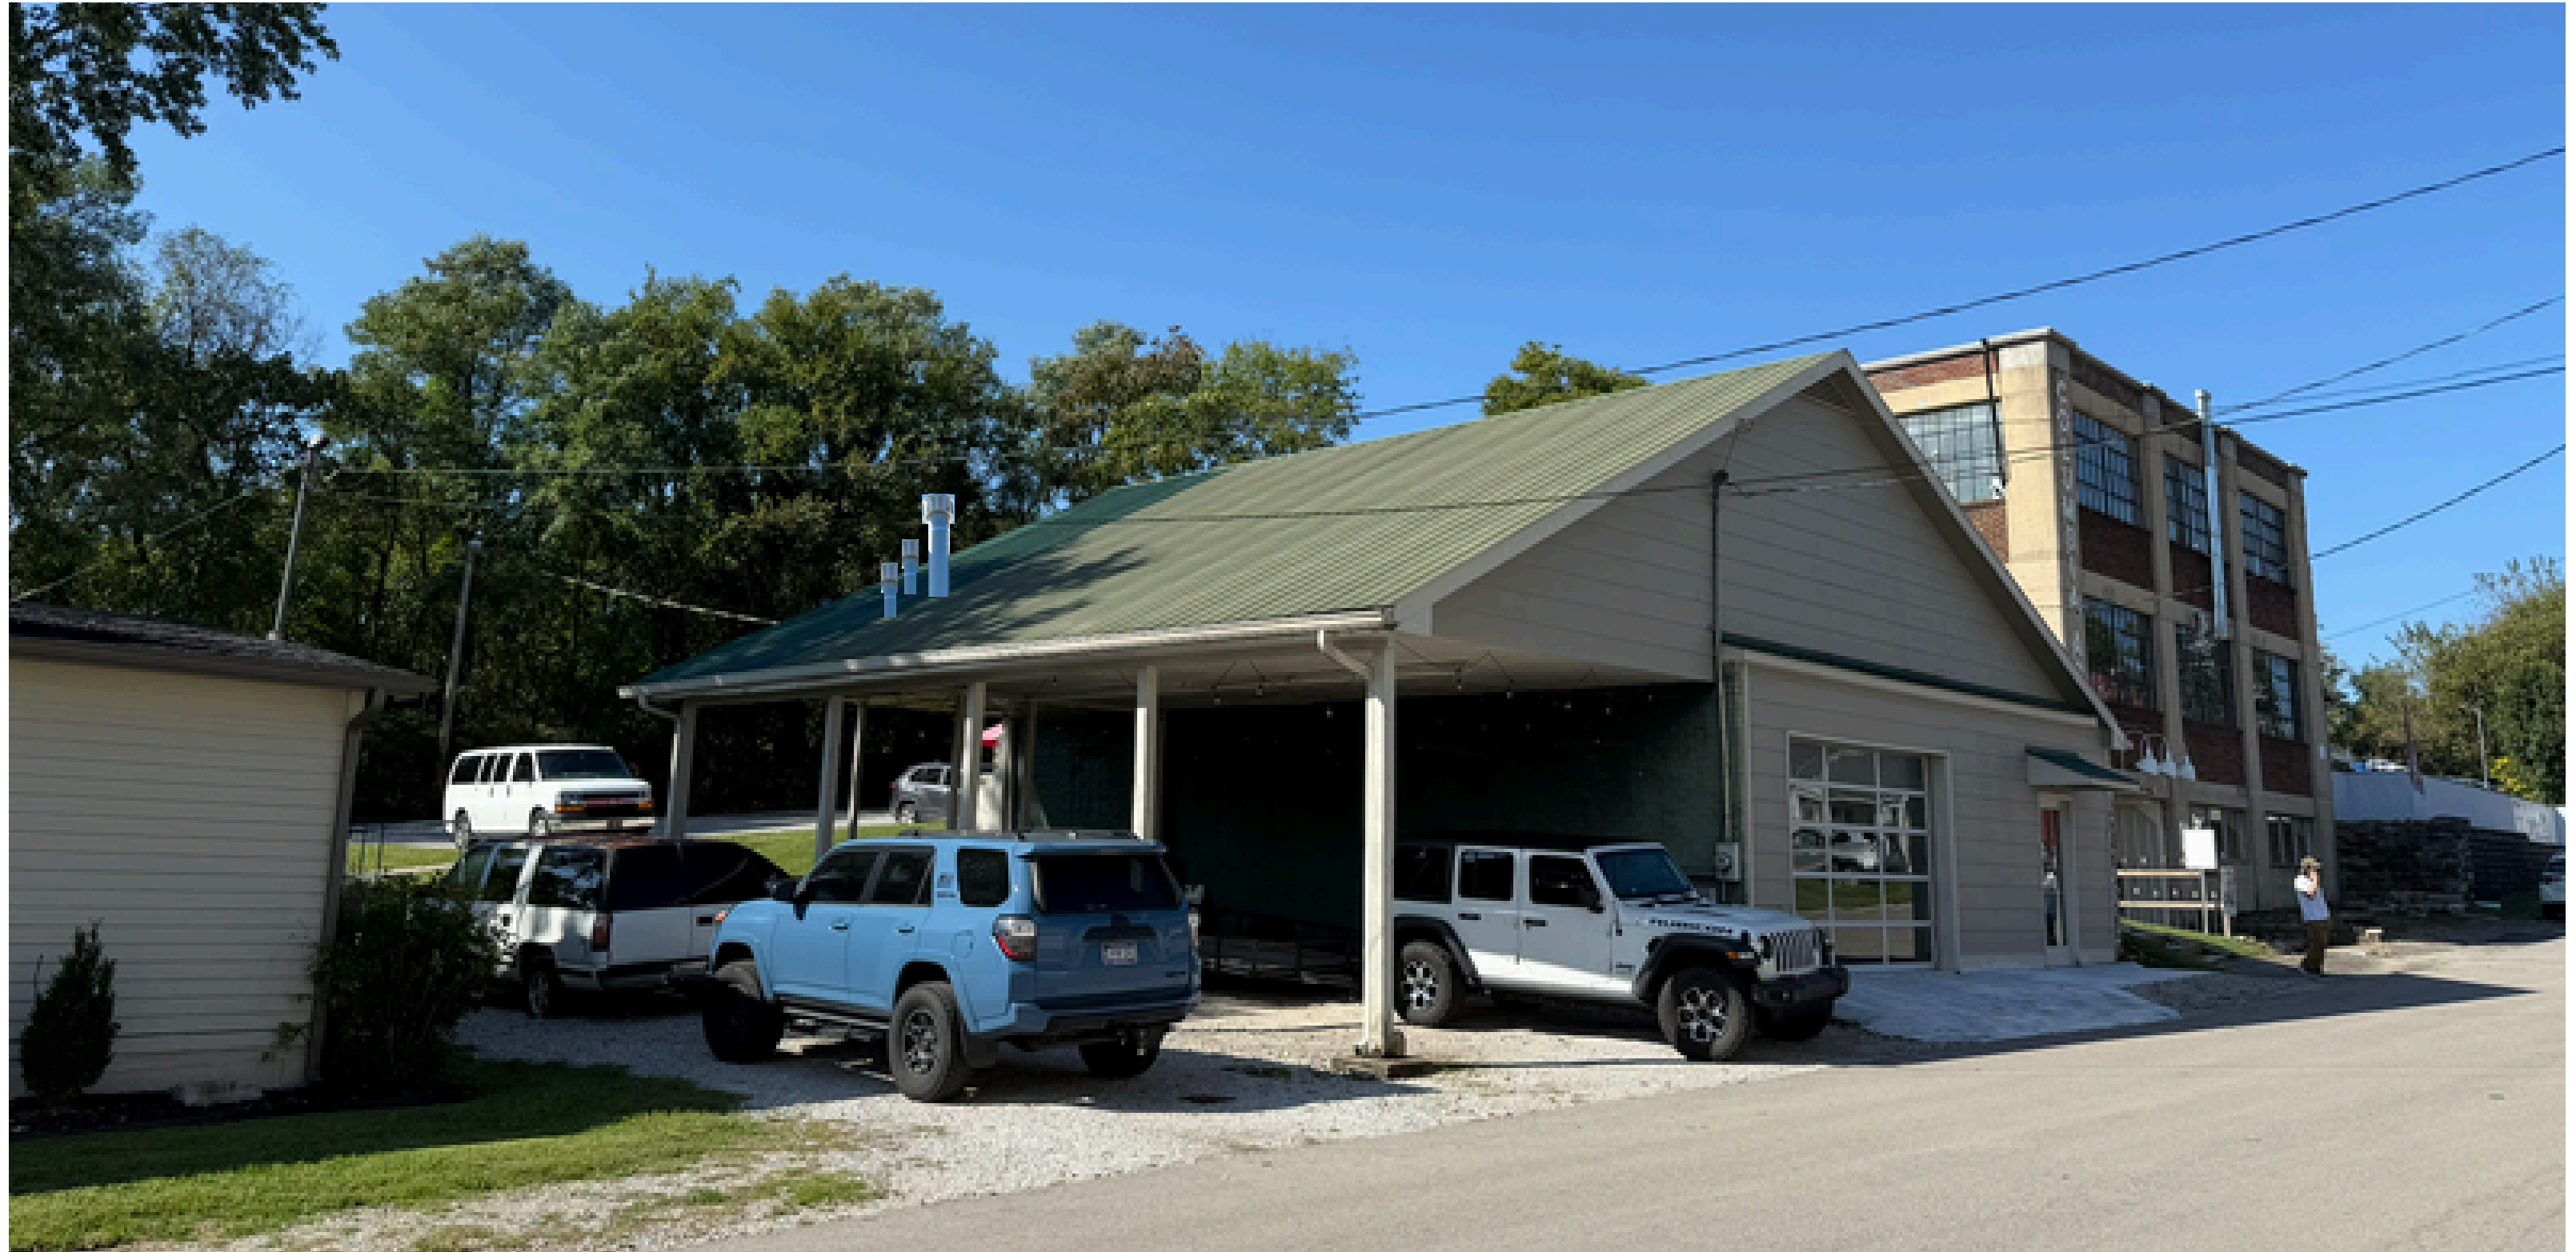
View from S. High Street - shows example of 7' tall 12" boiler vent. Also shows 30" tall 2" return vent, and 30" tall 3" blowdown vent which may not be required depending on final equipment selection.
