The Columbia Historic Zoning Commission will meet on Wednesday, November 19, 2025 at 4:00 PM in Council Chambers on the basement level of City Hall, 700 N. Garden Street, to consider the following:

1. Request from Henderick, Inc. for exterior alterations approval at [1122 S. High Street](#), being Tax Map 100E Group E Parcel 17, *Athenaeum Historic District*.
2. Request from Drifter Bay Brewing Co. for exterior alterations approval at [305 W. 11th Street, being located at Tax Map 100E Group E Parcels 18 and 18.01](#), *Athenaeum Historic District*.
3. Request from Marlin Allen Lentz for exterior alterations approval at [222 W. 7th Street, located at Tax Map 99A Group J Parcel 42](#), *Downtown Commercial Historic District*.

**City of Columbia**  
HISTORICAL ZONING COMMISSION  
September 17, 2025

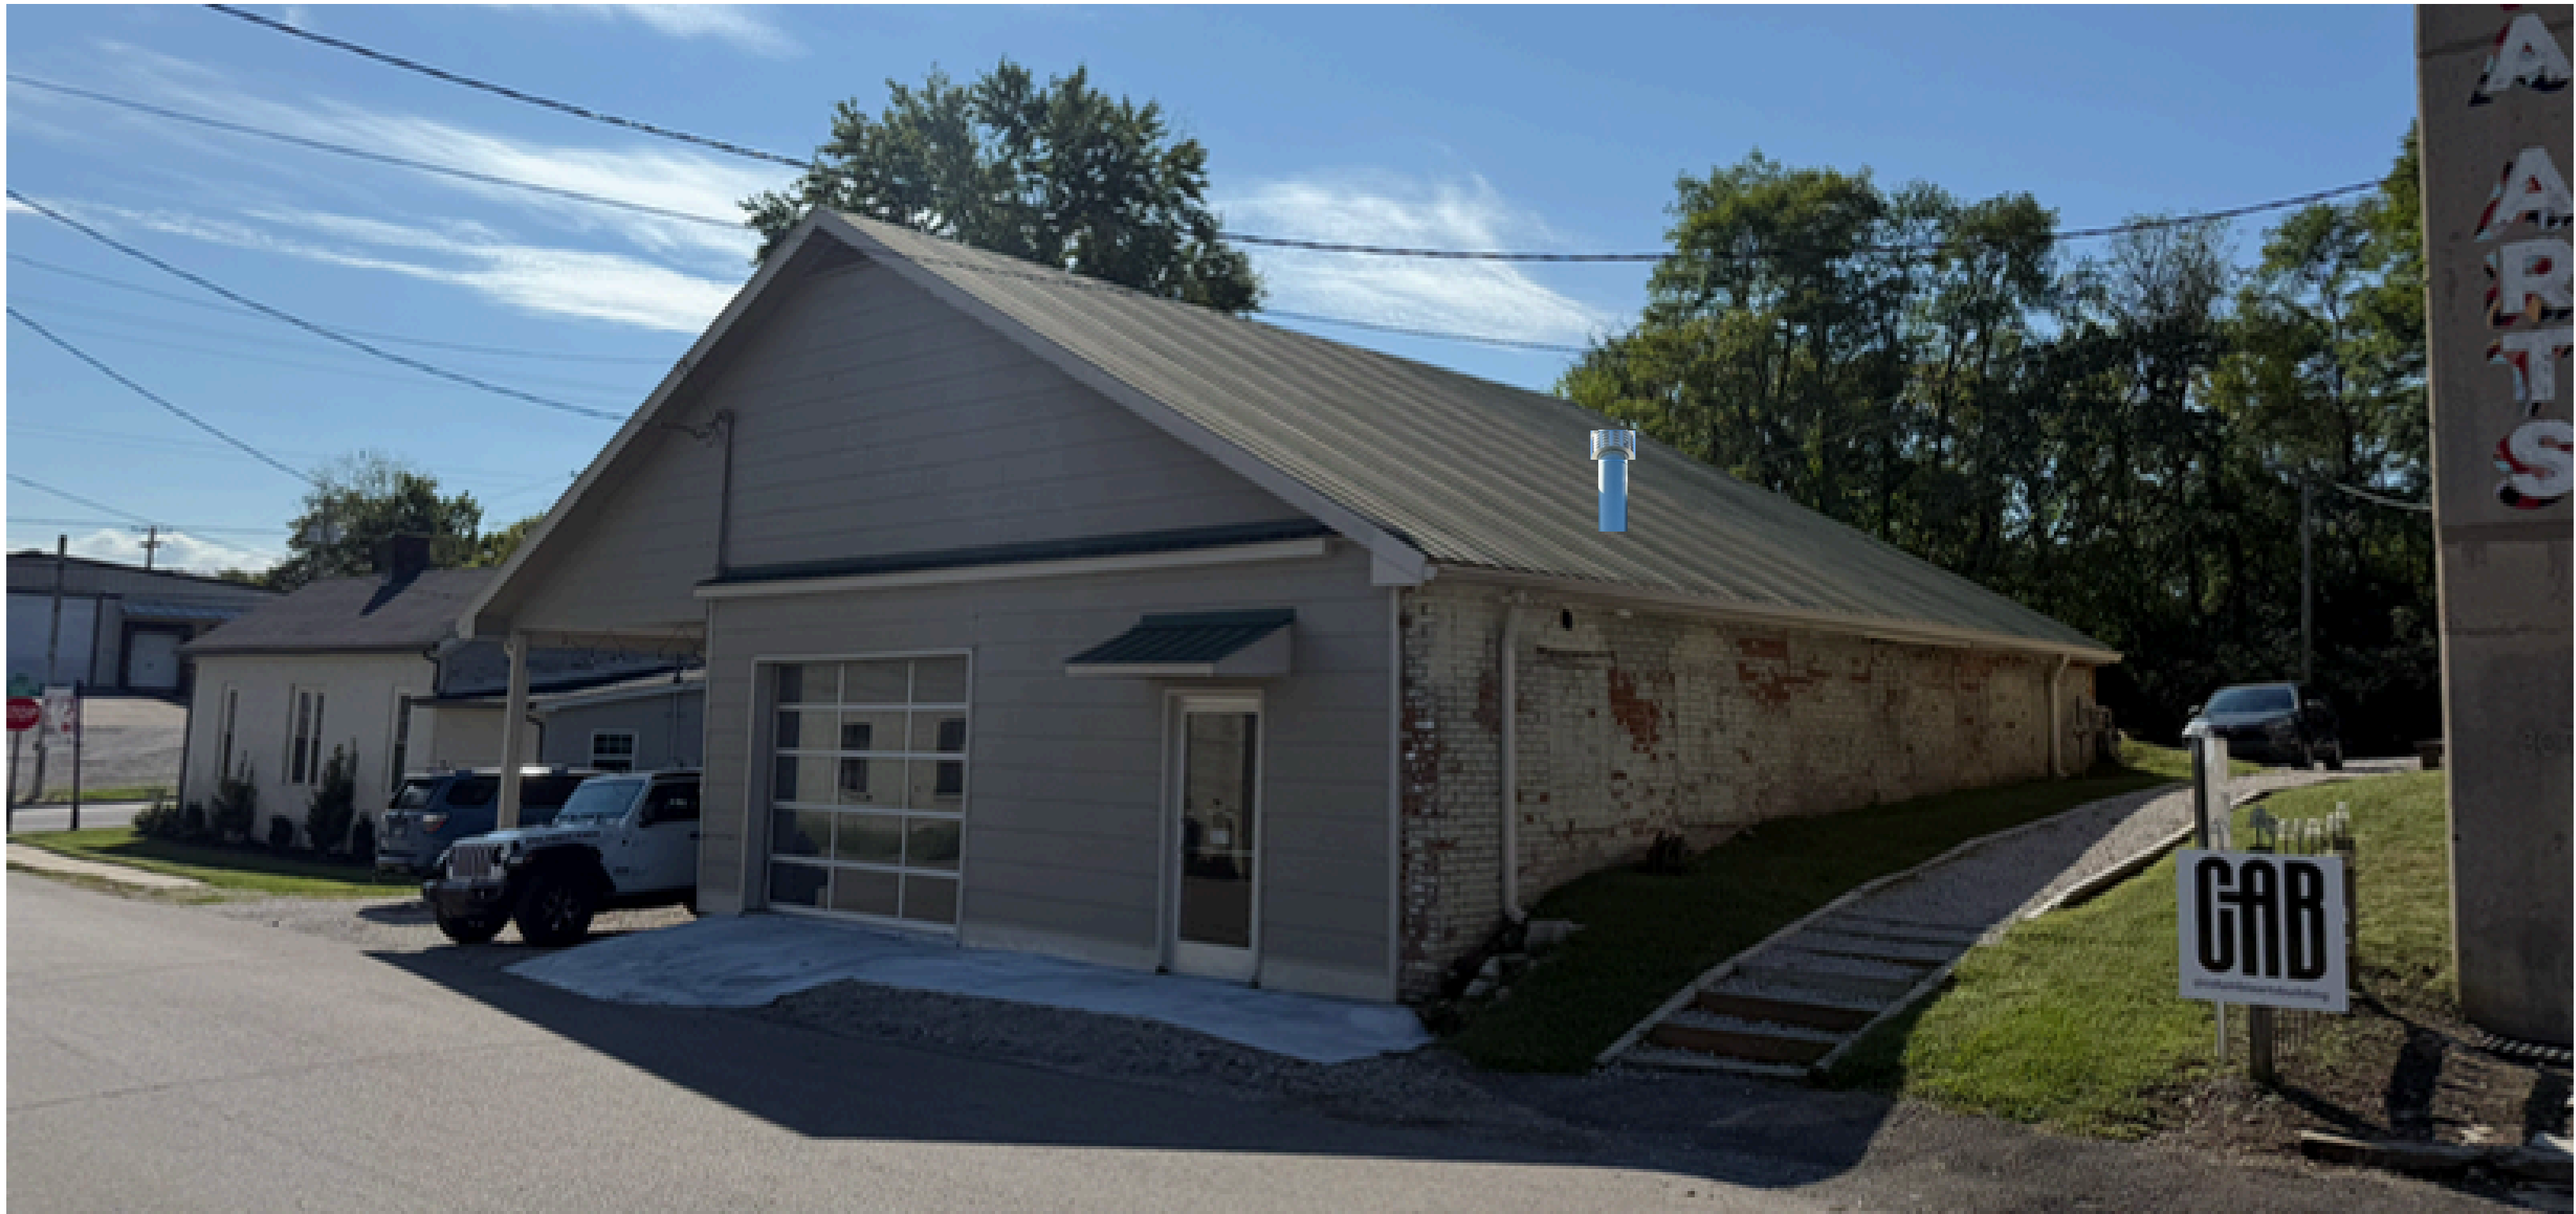
View from 11th Street - shows example of 30" tall 8" brewing evaporation vent which will have an exhaust fan.

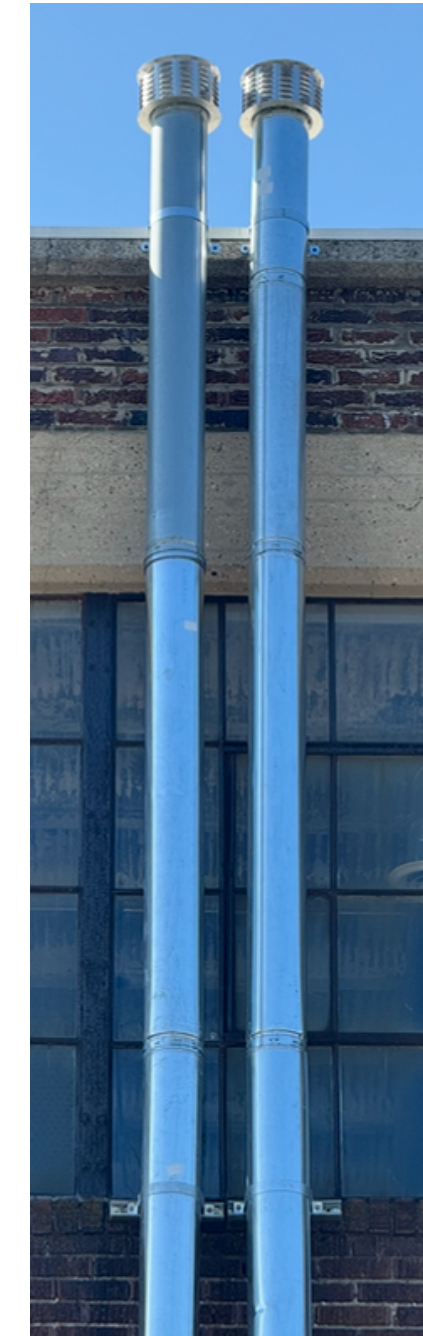
Similar Vent example from CAB

(Potential) Blowdown Evaporation Vent - 3" diameter galvanized with cap - 30" roof clearance

Brewing Evaporation Vent - 8" diameter stainless steel with fan/cap - 30" roof clearance

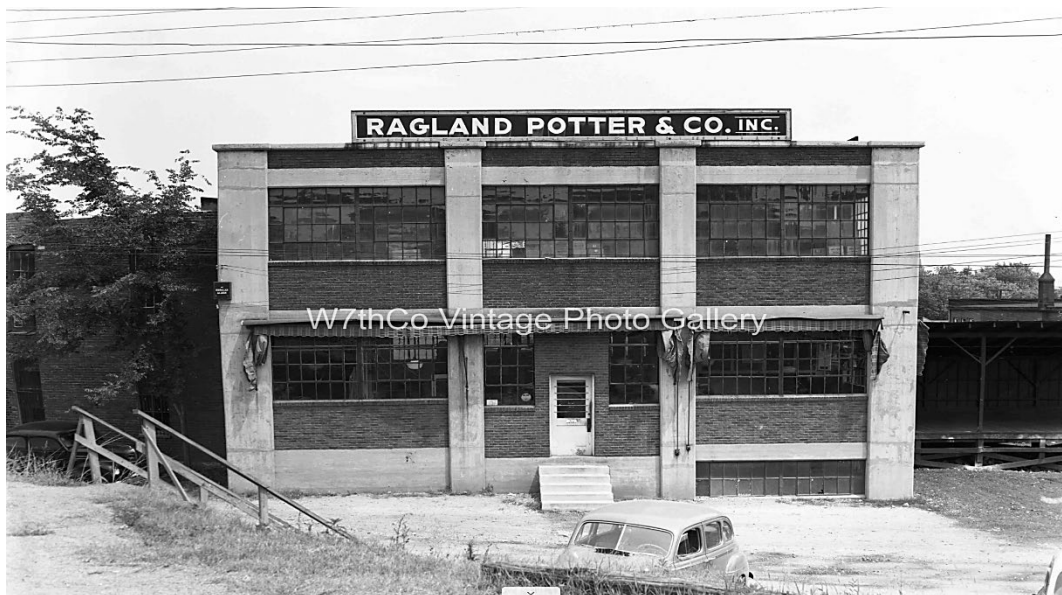
The structure in question was connected to the existing 1923 Ragland-Potter & Company Wholesale Grocery by a 1907 brick building that was unfortunately demolished in 1985 due to significant fire damage. As shown in the photo below, the original Ragland-Potter & Company Wholesale Grocery is visible to the left of the CAB Building. Based on the construction dates noted in the historic inventory, staff members believe that the current structure under review was originally used for storage by the 1907 grocery company before the construction of the circa 1923 CAB building, which is recognized as the Ragland-Potter & Company Wholesale Grocery store.

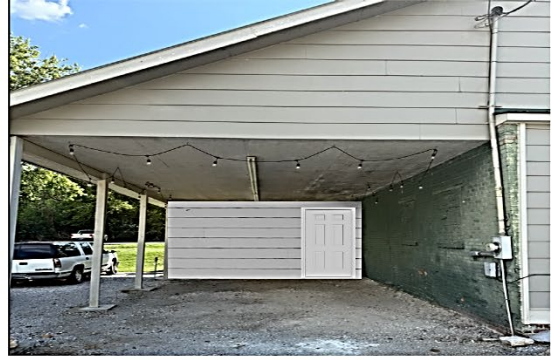
Create walls to match existing siding around the back area.  
 This will shield the new boiler on all 3 exposed sides.  
 There will be 2 fixed louvers on the left wall and a door on the front wall.

Create walls to match existing siding around the back area.  
This will shield the new boiler on all 3 exposed sides.  
There will be 2 fixed louvers on the left wall and a door on the front wall.

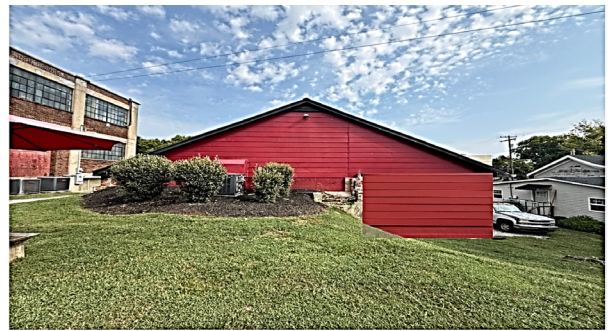
Shown with wall extended to screen boiler equipment in the back of the carport, match existing siding

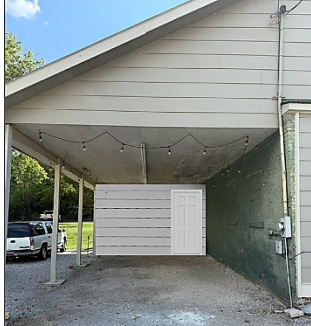
*Proposed new opening for boiler room*

*Staff suggests the Historic Commission require the applicant to install a similar door in the new wall that would mirror the existing façade door to provide a more visually aesthetic façade from the Frontage.*

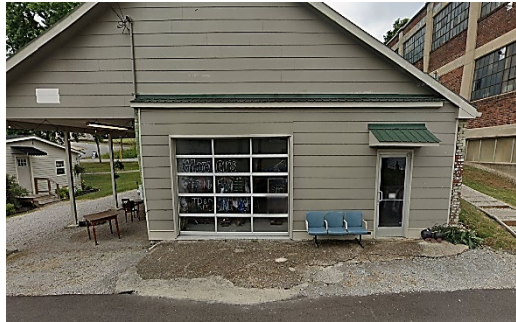
*Existing facade*

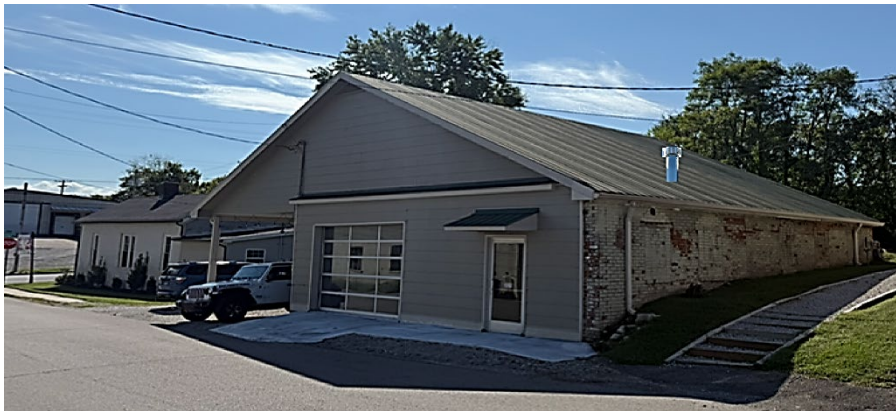
*Staff suggest that if feasible, the applicant relocate the exhaust from the front to closer to the rear of the structure to soften the projection from the Frontage.*

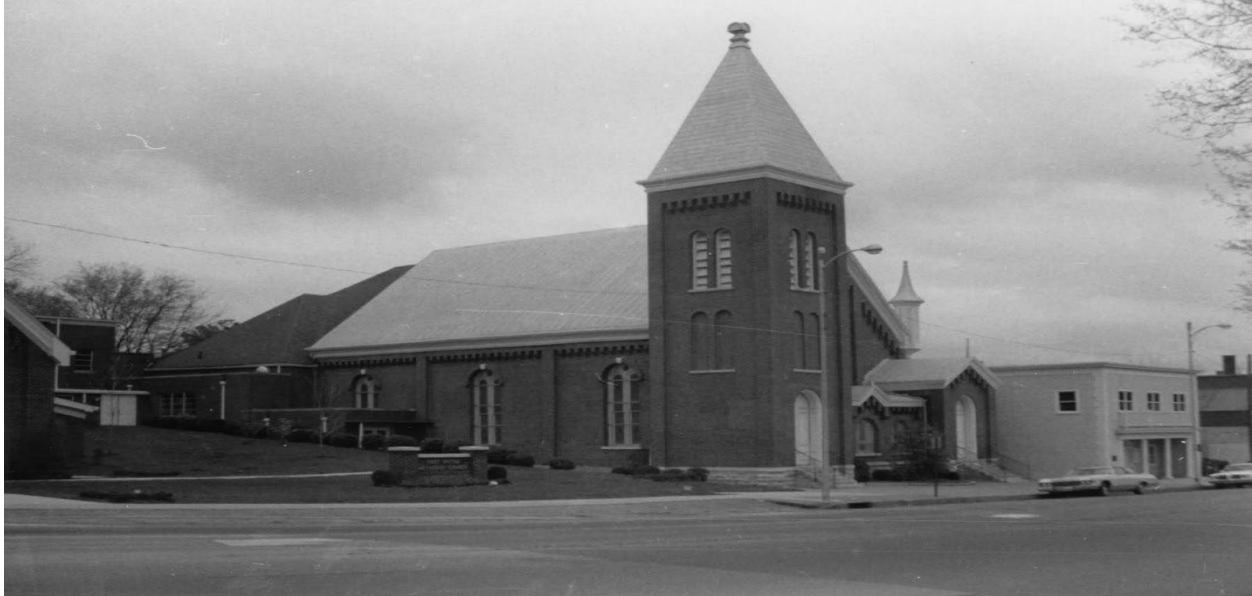
Figure 1 Photo of the First United Methodist Church of Columbia, c. 1984

*The Romanesque Revival style church (Figure 1) is a brick-framed structure with flanking towers on the south elevation (front) and a coursed ashlar cut limestone foundation. The southwest tower is 3 stories tall, and the southeast entrance tower is 1 story tall with double-leaf doors. Both towers have corner buttresses, a pyramidal tin roof, and arched openings. The main walls of the sanctuary have buttresses. The front gable end has a rose window, and below the molded wooden cornice is dogtooth brick corbeling. The side elevations (east and west) bays are separated by buttresses and 3 bays wide with stained glass memorial windows set in arched openings with brick voussoirs and center keystones. Below the eaves is a wooden cornice with brick corbeling below the cornice.<sup>i</sup>*

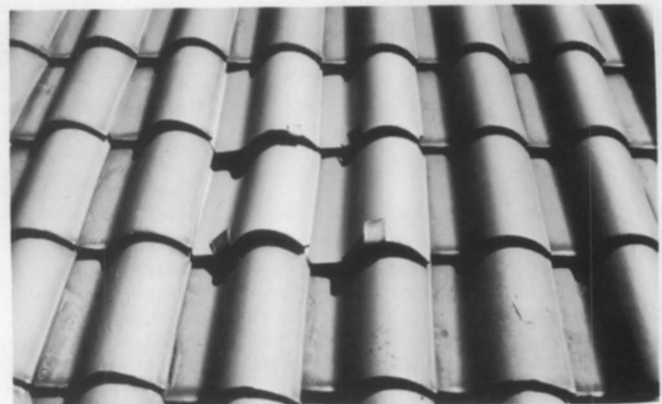
*Repairs on this pantile roof were made with new tiles held in place with metal hangers. (Main Building, Ellis Island, New York)*

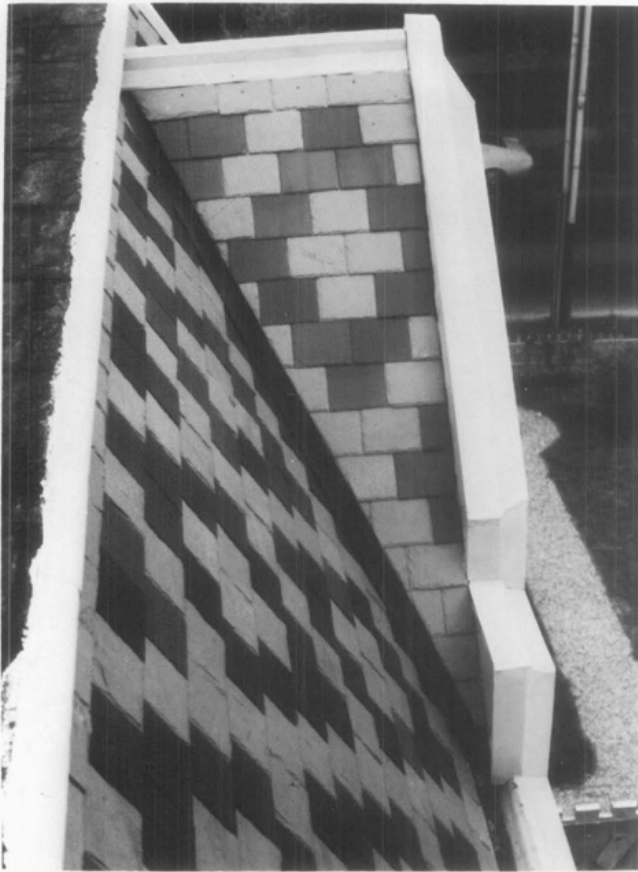
*The Victorians loved to use different colored slates to create decorative patterns on their roofs, an effect which cannot be easily duplicated by substitute materials. Before any repair work on a roof such as this, the slate sizes, colors, and position of the patterning should be carefully recorded to assure proper replacement. (Ebenezer Maxwell Mansion, Philadelphia, Pennsylvania, photo courtesy of William D. Hershey)*

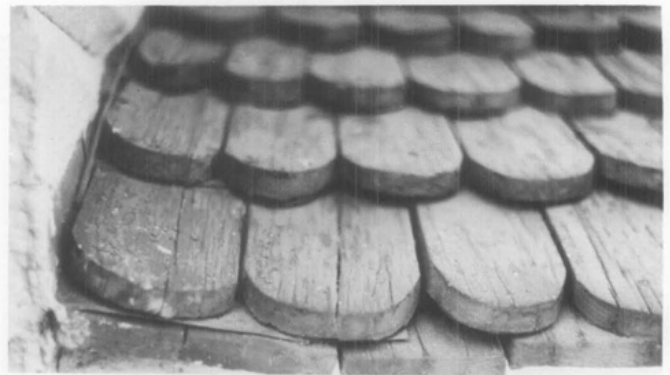
*Replacement of particular historic details is important to the individual historic character of a roof, such as the treatment at the eaves of this rounded butt wood shingle roof. Also note that the surface of the dormer was carefully sloped to drain water away from the side of the dormer. In the restoration, this function was augmented with the addition of carefully concealed modern metal flashing. (Mount Vernon, Virginia)*

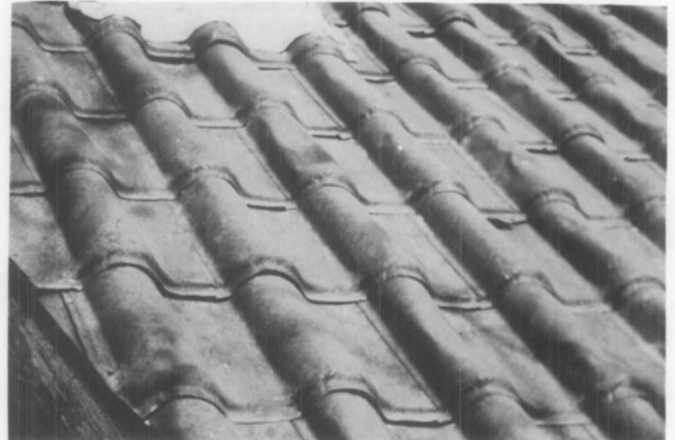
*Galvanized sheet-metal shingles imitating the appearance of pantiles remained popular from the second half of the 19th century into the 20th century. (Episcopal Church, now the Jerome Historical Society Building, Jerome, Arizona, 1927)*

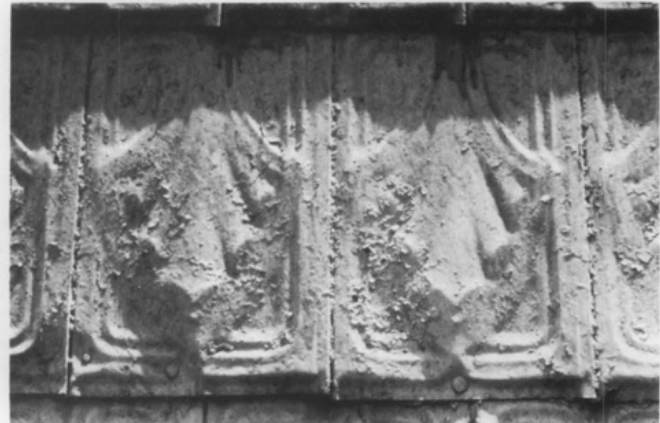
Tin shingles, commonly embossed to imitate wood or tile, or with a decorative design, were popular as an inexpensive, textured roofing material. These shingles  $8\frac{3}{8}$  inch by  $12\frac{1}{2}$  inch on the exposed surface) were designed with interlocking edges, but they have been repaired by surface nailing, which may cause future leakage. (Ballard House, Yorktown, Virginia, photo by Gordie Whittington, National Park Service)

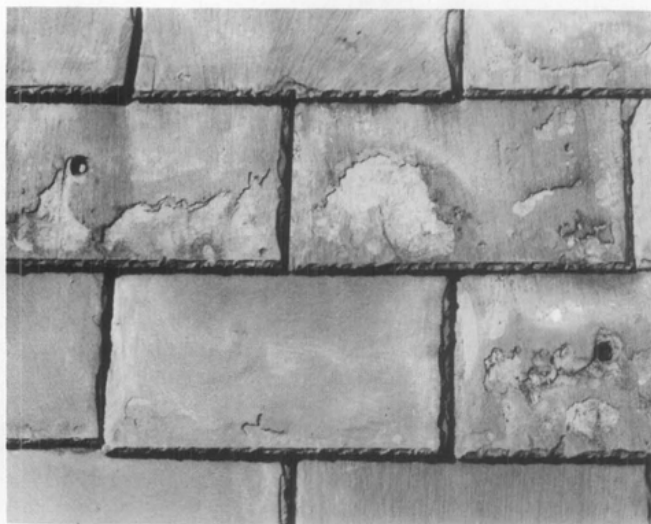
*This detail shows slate delamination caused by a combination of weathering and pollution. In addition, the slates have eroded around the repair nails, incorrectly placed in the exposed surface of the slates. (Lower Pontalba Building, New Orleans, photo courtesy of Building Conservation Technology, Inc.)*

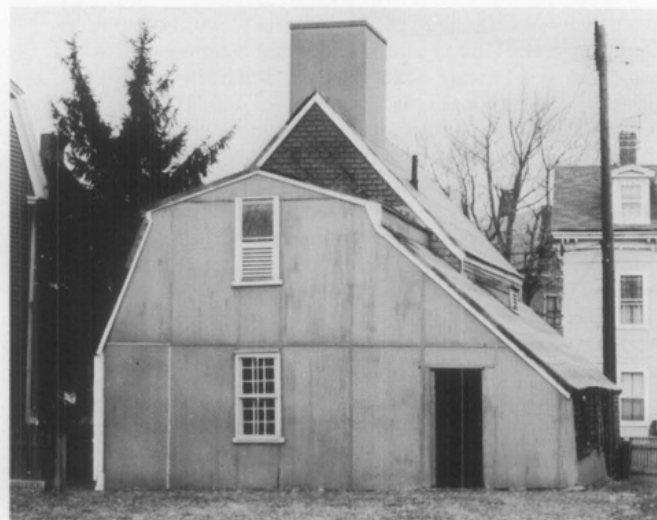
*Temporary stabilization or "mothballing" with materials such as plywood and building paper can protect the roof of a project until it can be properly repaired or replaced. (Narbonne House, Salem, Massachusetts)*

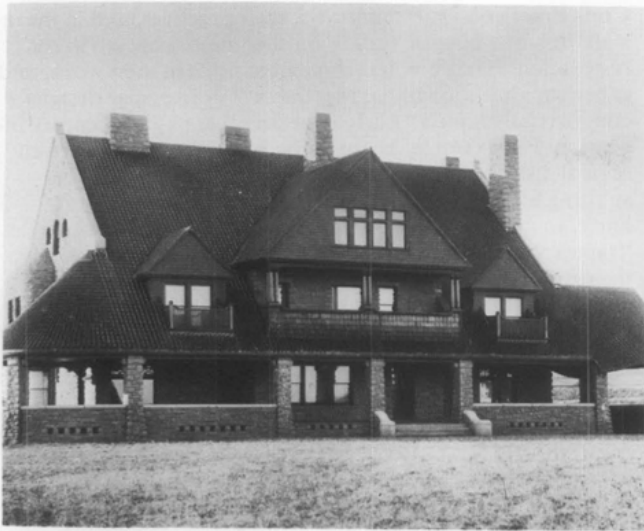
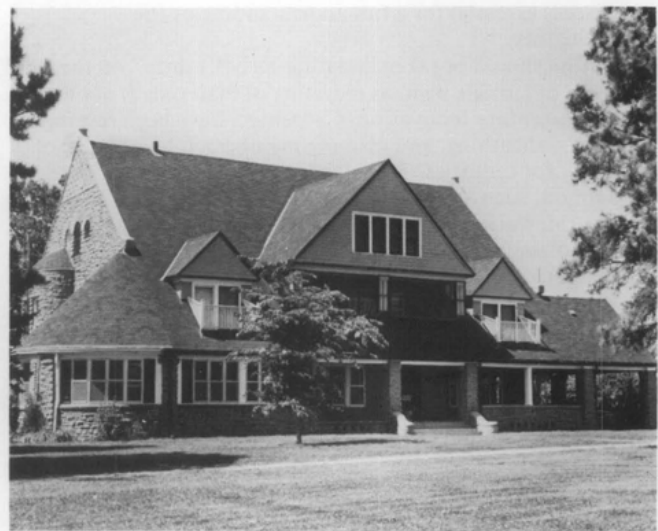
*These two views of the same house demonstrate how the use of a substitute material can drastically affect the overall character of a structure. The textural interest of the original tile roof was lost with the use of asphalt shingles. Recent preservation efforts are replacing the tile roof. (Frank House, Kearney, Nebraska, photo courtesy of the Nebraska State Historical Society, Lincoln, Nebraska)*

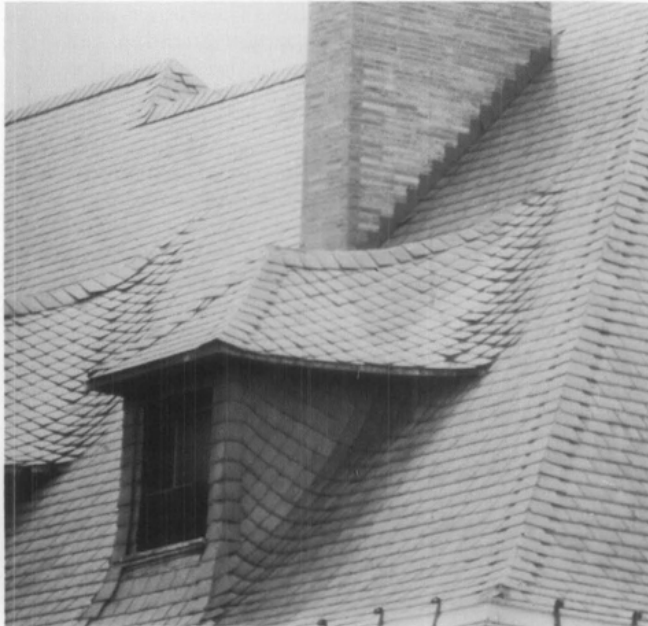
*Because of the roof's visibility, the slate detailing around the dormers is important to the character of this structure. Note how the slates swirl from a horizontal pattern on the main roof to a diamond pattern on the dormer roofs and side walls. (18th and Que Streets, NW, Washington, D.C.)*

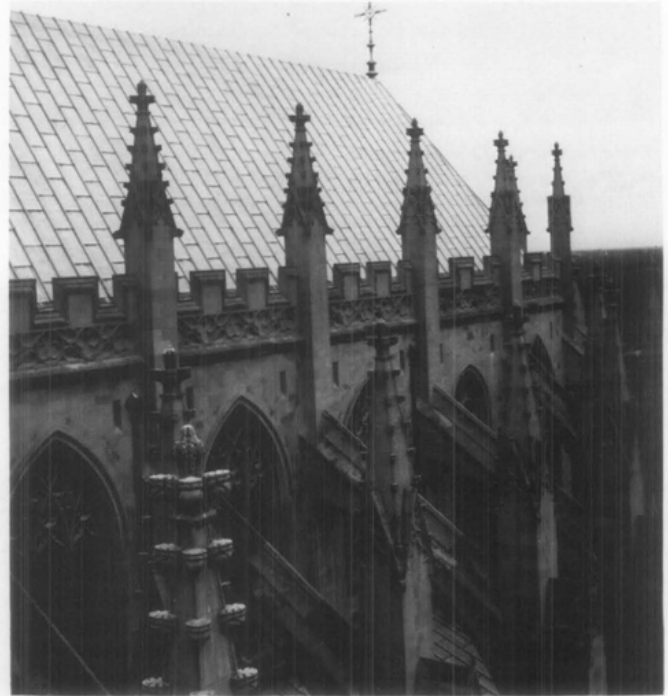
*Good design and quality materials for the roof surface, fastenings, and flashing minimize roofing failures. This is essential on roofs such as on the National Cathedral where a thorough maintenance inspection and minor repairs cannot be done easily without special scaffolding. However, the success of the roof on any structure depends on frequent cleaning and repair of the gutter system. (Washington, D.C., photo courtesy of John Burns, A.I.A.)*

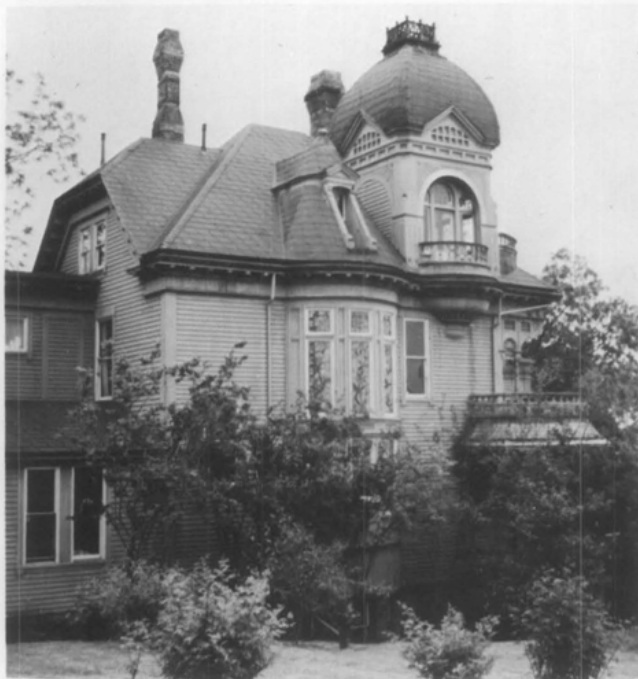
*Special problems inherent in the design of an elaborate historic roof can be controlled through the use of good materials and regular maintenance. The shape and detailing are essential elements of the building's historic character, and should not be modified, despite the use of alternative surface materials. (Gamwell House, Bellingham, Washington)*

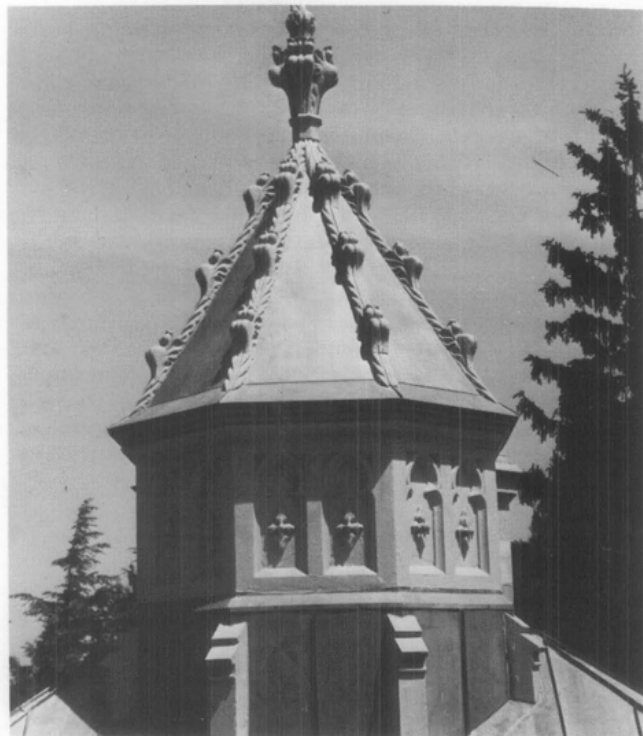
Decorative features such as cupolas require extra maintenance. The flashing is carefully detailed to promote run-off, and the wooden ribbing must be kept well-painted. This roof surface, which was originally tin plate, has been replaced with lead-coated copper for maintenance purposes. (Lyndhurst, Tarrytown, New York, photo courtesy of the National Trust for Historic Preservation)
